AFAL-TR-75-112

## K-RB LASER PUMP LAMP

LC TECHNOLOGY  
64 COMMERCIAL ST.  
SUNNYVALE, CA 94086

TECHNICAL REPORT AFAL-TR-75-112  
FINAL REPORT FOR PERIOD NOVEMBER 1973 -- FEBRUARY 1975

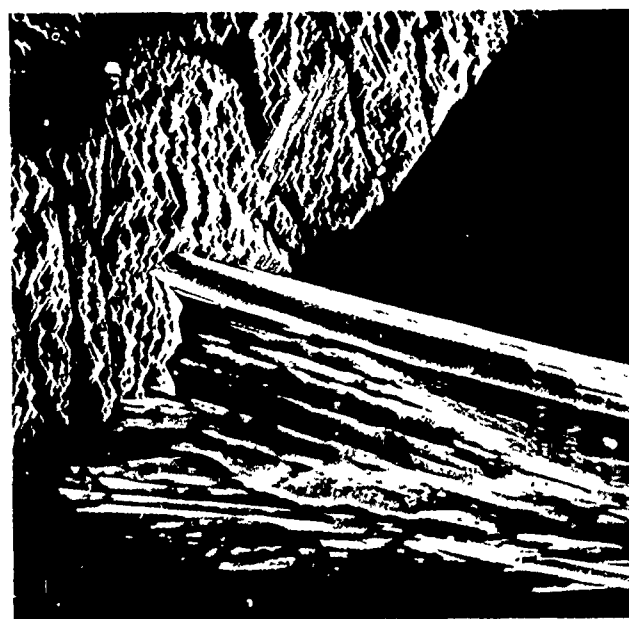
5358

Figure 8. SEM Photomicrograph of Envelope Frosting Site (500X)

After 300 hours of operation, lamp No. 451 was dissected and its internal envelope surface examined with a scanning electron microscope (SEM). Hexagonal shaped crystallites containing aluminum and potassium (as determined by concurrent x-ray analysis) were found at the reaction sites. A representative SEM photomicrograph is shown in Figure 8.
